## Are you exposing your family to deadly asbestos fibres?

# Potential sources of asbestos

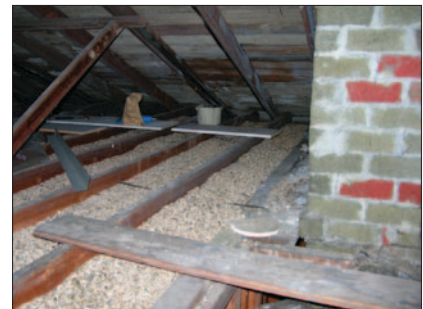
*Asbestos-containing vermiculite attic insulation*

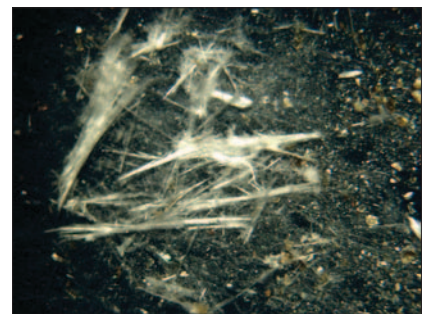
*Asbestos fibres in vermiculite attic insulation*

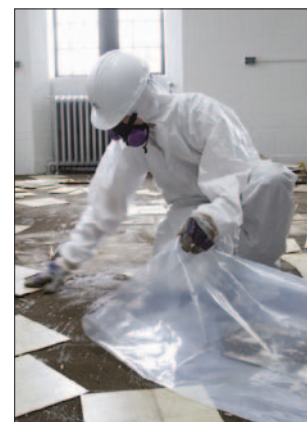
*Protected worker removing asbestos flooring*

For safety, all asbestos-containing materials must be removed by workers trained in asbestos removal and wearing protective clothing and a respirator. Unless you're trained and qualified, don't try it yourself. You are responsible if unprotected workers are exposed to asbestos while working in your home!
